Landslide Stabilization Using High Strength Aggregate-Cement Slurry

Gregory Silver¹, M.Sc., P.E., G.E., ASCE, CalGeo; and Lisa Bates², P.G., C.E.G.

ABSTRACT: Most large landslides are repaired via some combination of mass grading, structural restraint systems, and/or dewatering. A deep seated landslide occurred in Dana Point, California, in 2005 that resulted in the destruction of one home and the red-tagging of three others. Several attempts were undertaken to completely repair the landslide over a five-year period, but all attempts failed due to a lack of funds and concerns over landslide enlargement into adjacent properties. During preliminary design, a repair scheme was developed involving conventional grading and stabilization methods. To mitigate the potential for off-site landslide enlargement, an expensive caisson and tieback active restraint system needed to be integrated into the repair, along with a large toe surcharge and buttress for stability. However, this system resulted in the repair scheme being economically and logistically unviable. A unique repair scheme was then developed in conjunction with the contractor that utilized a high strength aggregate-cement slurr

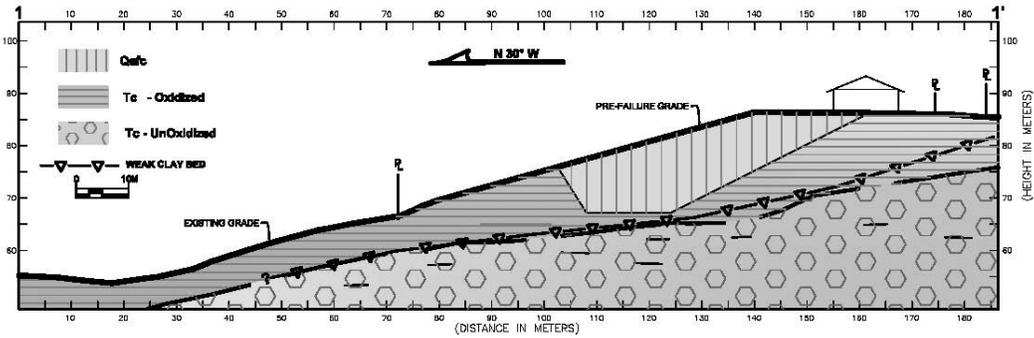
FIG. 2. Cross Section of Pre-failure Conditions

The failure that occurred in 2005 was likely due to adverse geologic structure exacerbated by saturated soil and bedrock conditions. A thin, highly plastic, adversely oriented clay bed was observed at the base of the failure just above the unoxidized bedrock (see Figure 2). The elevation of this clay bed places it below the original keyway constructed in 1984, causing it to be ineffective in preventing the failure (Figure 3). In addition, the general geologic structure underlying the site is a synclinal structure with an axis oriented in the downslope direction, creating a gently curving bowl-like shape, which likely contributed to the perched water condition and subsequent failure of the material along the saturated weak clay bed. As discussed above, this type of geologic scenario within the oxidized Capistrano Formation is highly prone to failure.

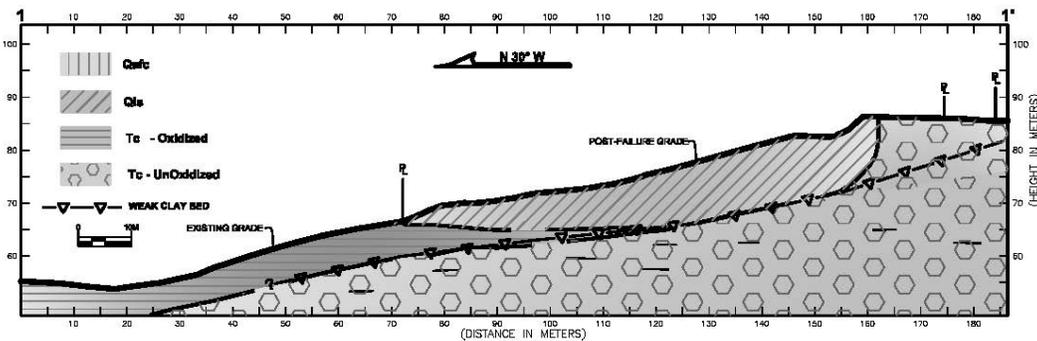
FIG. 3. Cross Section of Post-failure Conditions

The slope remained in service with no recorded problems until the early 2000's when some repairs were completed to address what was thought to be at the time "slope creep issues". In the spring of 2005, after record heavy rainfall, the slope grossly failed (Figure 3). The resulting damage included demolition of one home, emergency underpinning of a second home, and significant distress to the rear yards of two other homes.

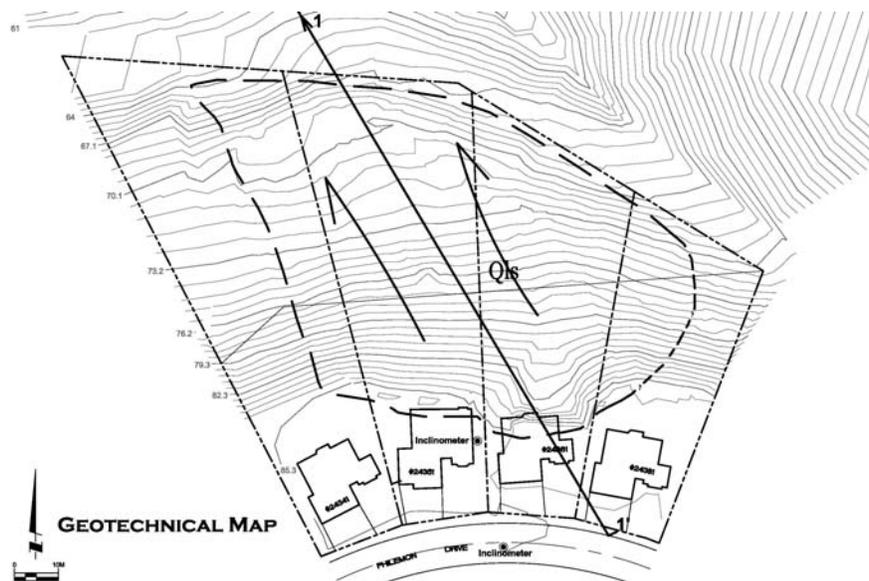
FIG. 4. Geotechnical Map

During the winter of 2009 and 2010, minor ground cracking was observed along the limits of the landslide, indicating that movement was slowly occurring (i.e., creeping). A winterization plan was developed to minimize the potential for future movements until a permanent repair could be implemented. The plan consisted of three components: 1) the installation of horizontal drains; 2) re-grading of the slope face; and, 3) surface drainage improvements. Following the implementation of winterization, it was noted via visual observations that the rate of landslide movement was significantly decreased, but some movement was still occurring. In addition, the horizontal drains were producing small outflows of water. Two slope inclinometers installed by previous consultants (Figure 4 – Geotechnical Map) were monitored during and following the winterization. These inclinometers indicated that the movements were limited to the landslide mass.

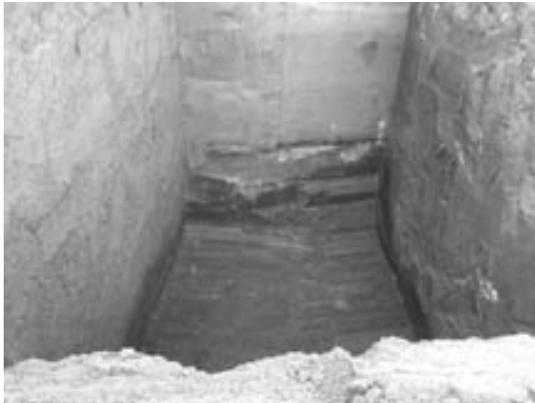
FIG. 8. ACS slots

The Cat 345 excavator was set up on an equipment bench at the toe of the keyway, and was used to excavate the ACS slots (Figure 8). After excavation and verification that the slot had been excavated into unoxidized bedrock, cement and water were mixed in the grout plant per the design mix ratio (Figure 9). The grout plant was located at the top of the site, adjacent to the residential street, so that cement delivery trucks could easily access the plant. The mixture of cement and water was then pumped via hose (Figure 10) to the mixer-excavator and into the side-mounted hopper (Figure 11). The mixer-excavator was set up on an equipment bench upslope of the keyway slot that was close enough to swing the discharge chute over the slot such that the ACS would pour directly into the slot. As the hopper filled with the cement-water mix (Figure 12), a loader was used to add a set amount of aggregate to the hopper (Figure 13). Once the hopper had mixed the aggregate cement and water together forming the ACS to the satisfaction of the engineering technician, the discharge chute was opened and the ACS was poured into the slot (Figures 14 and 15). The Cat 320 excavator with the vibrating rod was used periodically throughout the pour (Figure 15). If required for the slot construction, a form would be set up to complete the ACS pour to the design elevation (Figure 16). The poured slot would be allowed to cure overnight, and the following workday the ACS would be adequately set to allow removal of the form and excavation of the adjacent slot with no adverse affects on the previously poured section (Figure 17).

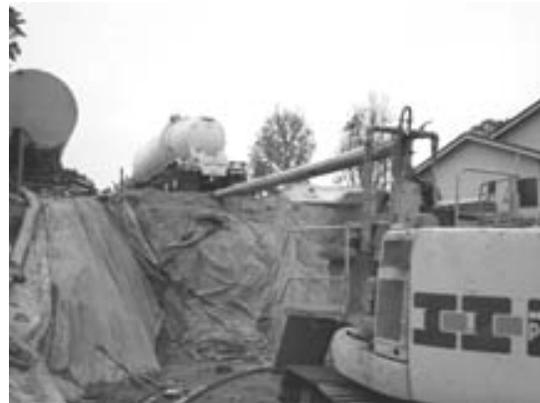
FIG. 9. Cement and water mixed in on-site grout plant

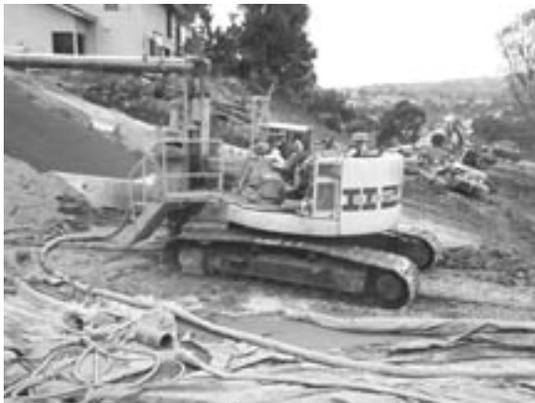
FIG. 10. Cement water mixture pumped through a hose

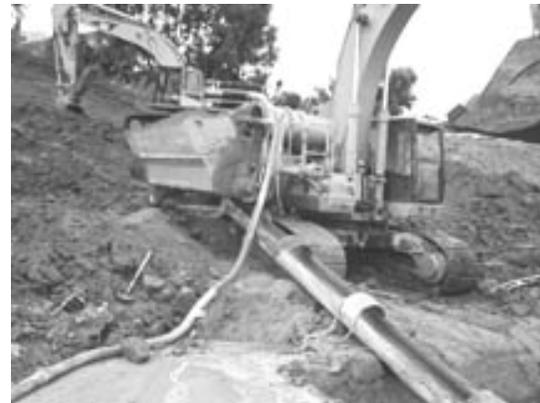
FIG. 11. Mixer-excavator with side-mounted hopper

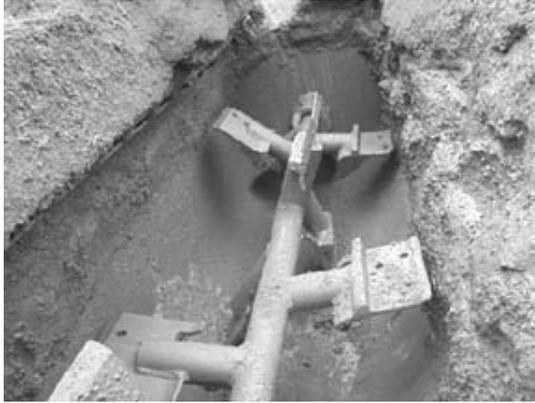
FIG. 12. Inside of hopper

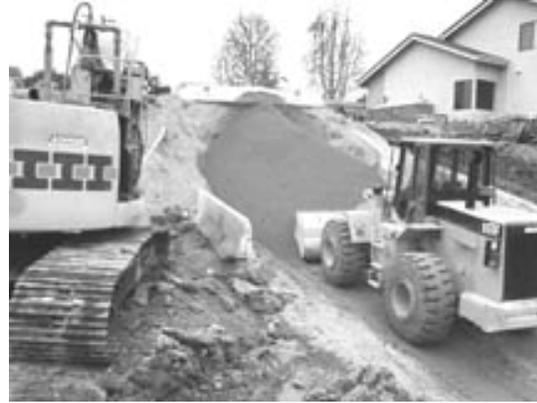
FIG. 13. Collecting aggregate to add to hopper

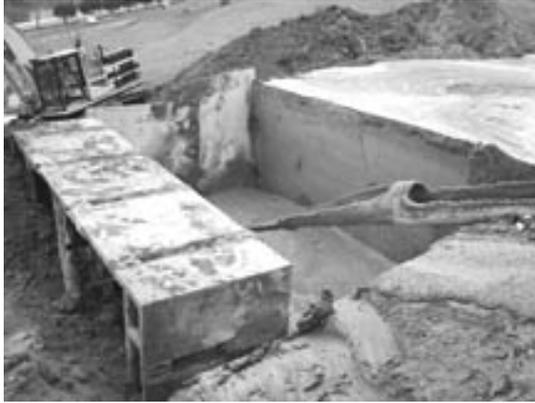
FIG. 14. ACS is poured into slot

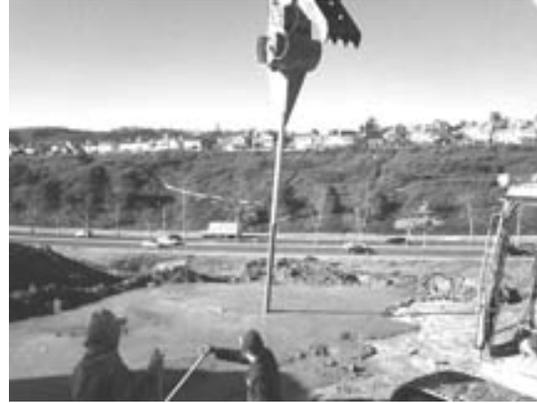
FIG. 15. Cat 320 excavator with vibrating rod

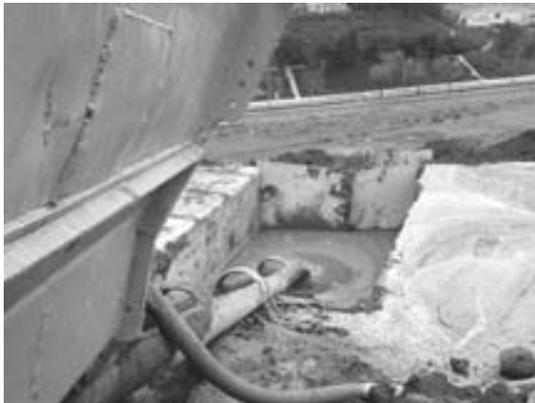
FIG. 16. A form was set up as needed to contain ACS pour

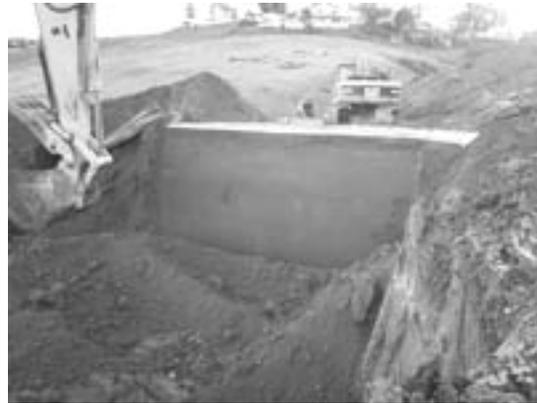
FIG. 17. Excavation of adjacent slot
